Defibrillator Lead Perforation Leading to Concerning Electrocardiogram Findings: Case Report

Bryan Rosenberg, MD*
Max Hockstein, MD*
Cyrus Hadadi, MD†

DOI: 10.5811/cpcem.1466

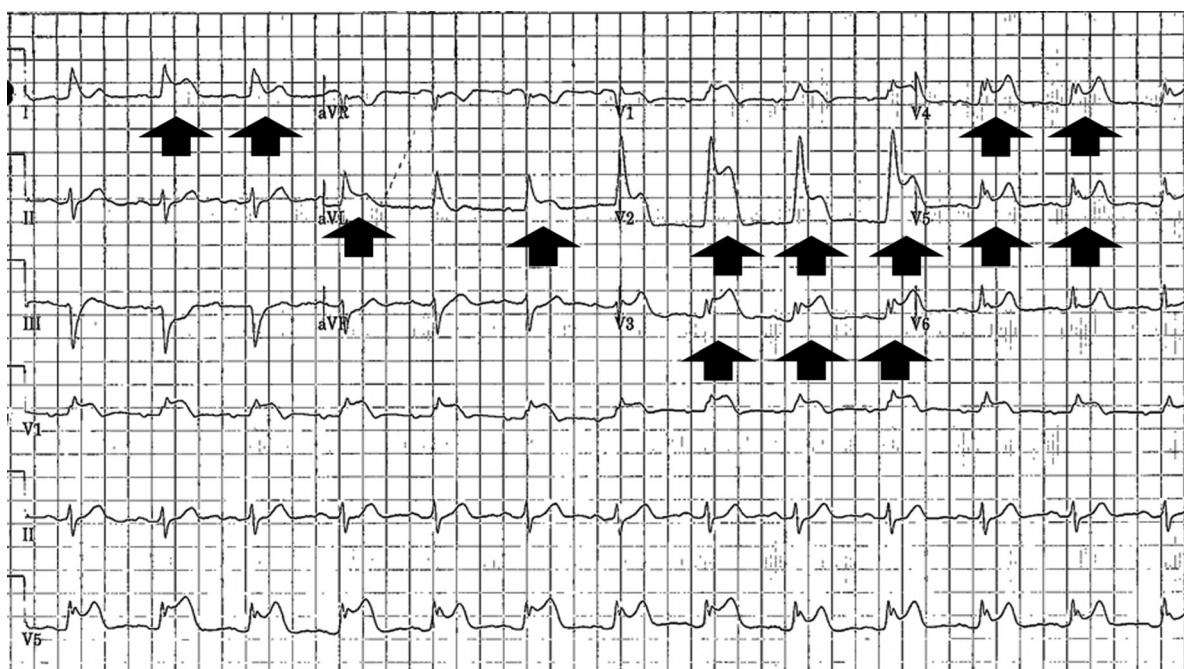
weeks earlier. She was seen earlier in the day at electrophysiology clinic and was noted to have changes in RV lead impedances and diaphragmatic stimulation during threshold testing. Therefore, she was sent to the ED for further management. Upon arrival to the ED, an ECG was performed (Image 1), which showed a normal sinus rhythm, left axis deviation, and significant ST-segment elevation across the precordial and high lateral leads.

With a history of ischemic-type chest pain, this ECG was concerning for an acute STEMI. However, with the patient's history of recent ICD placement in addition to large and diffuse ST-segment elevations, it was deemed more likely to be an ICD complication causing a current of injury than an ischemic event. A high sensitivity troponin was found to be within normal limits, and point-of-care ultrasound showed preserved left ventricular function and no evidence of pericardial effusion. Computed tomography chest demonstrated the RV lead tip extending through the

Image 1. Initial electrocardiogram on presentation to the emergency department showing ST-segment elevations (arrows) across the precordial and high lateral leads.

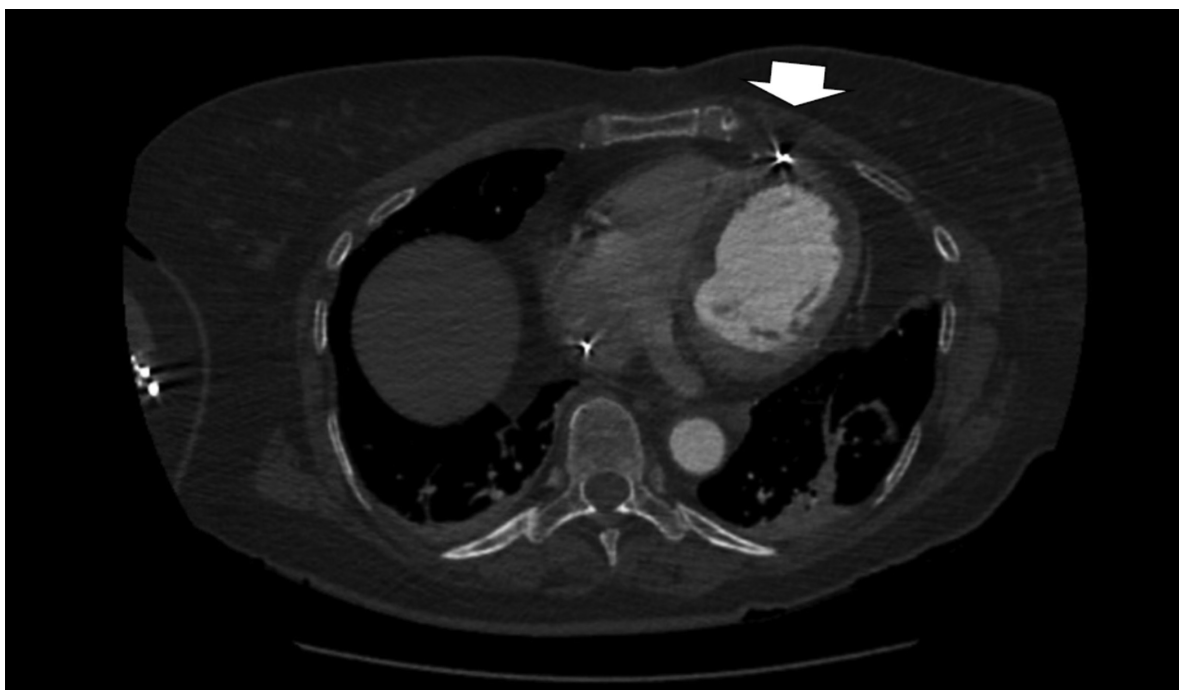
myocardium, epicardial fat, and pericardium, with its tip in the pericardiac fat, again without evidence of pericardial effusion or mediastinal collection (Image 2).

Image 2. Computed tomography chest showing the right ventricular lead tip perforating into the pericardial fat (arrow).

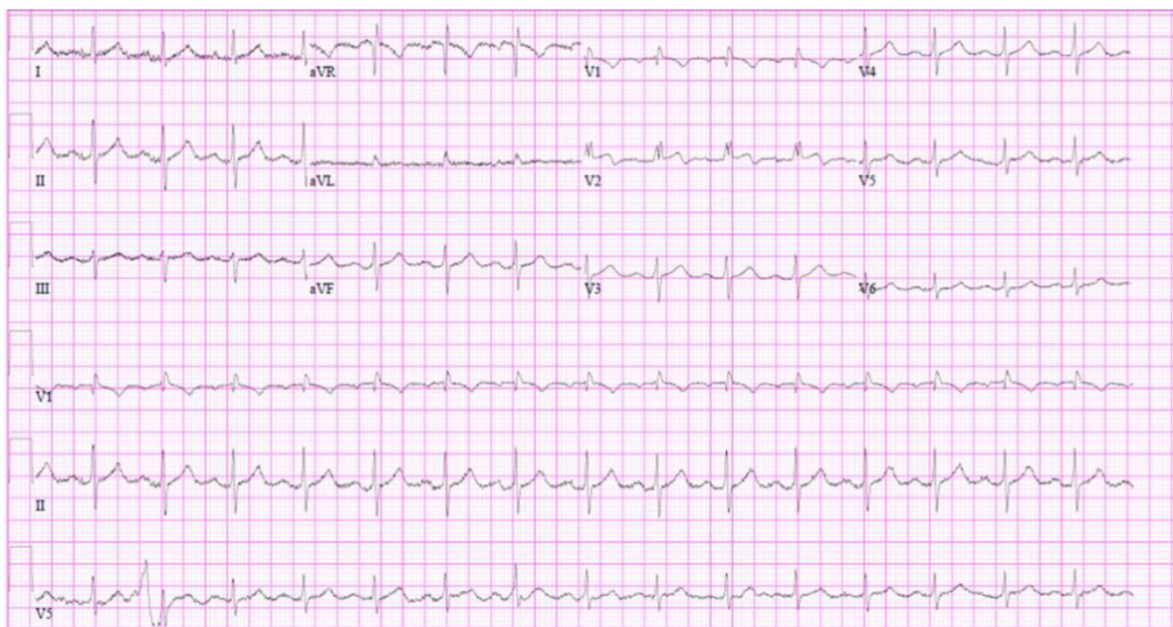
Image 3. Electrocardiogram showing resolution of ST-segment elevations after perforated pacer lead was successfully revised.

The patient exhibited no hemodynamic perturbations throughout her ED stay, and she was admitted to the electrophysiology service for continued care. During her hospital stay, serial troponins remained low, and the perforated RV lead was revised. The ECG from after the RV lead revision showed resolution of the ST-segment changes (Image 3). Her hospital course was complicated by an episode of ventricular tachycardia with an effective ICD shock in the setting of likely coronary vasospasm. The patient recovered well and was discharged five days after initial presentation.
