# A brief overview of climatization strategies of historic houses in the Netherlands: From “one size fits all” to “a process of deliberation”

*Bart Ankersmit and Marc Stappers*

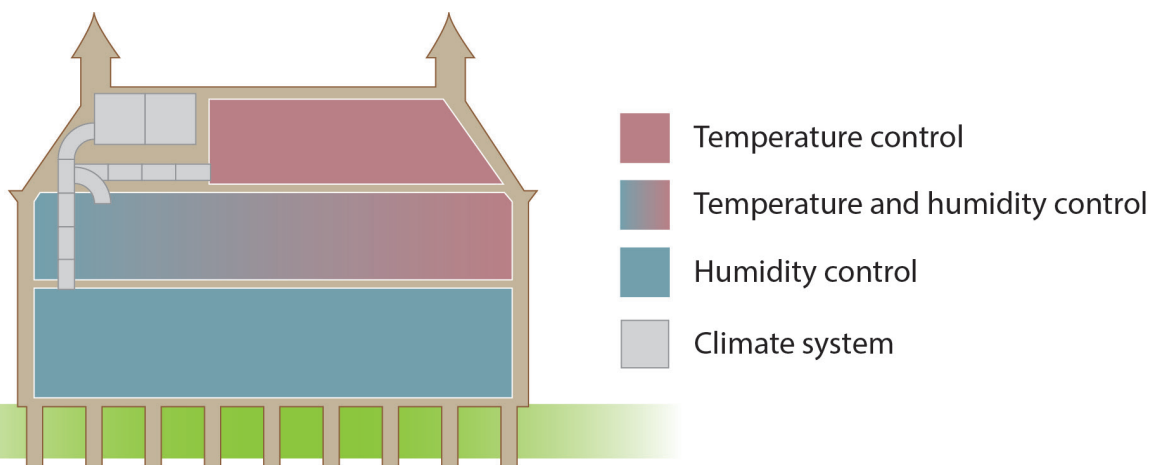
**IMAGE 16.** The climate strategy of Museum Oud Amelisweerd is carried out by separating three layers—collection comfort, collection and human comfort, and human comfort—to accommodate the differing functions. BART ANKERSMIT

To achieve optimum climate conditions on the ground floor, a conservation heating system was installed. Within bandwidths the relative humidity is created by controlling the temperature. A low-capacity climate control

system with heating, cooling, and dehumidification function was placed in the attic (Image 16). Air ducts and nozzles are hidden in the fireplaces. No ducts that affected the historic structure had to be installed. This system results in low temperatures in winter that are uncomfortable to visitors. On the first floor a slightly higher temperature is maintained, while in the attic a visitor center allows comfort temperatures to be maintained. This way, the house is split into three different climate zones: a ground floor in which optimum conditions to preserve the wallpapers is maintained, on the first floor a mixed zone with a slightly higher temperatures and controlled relative humidity, while on the third floor (attic) visitor comfort is key. Preservation of the wallpapers requires low temperatures, a more or less stable relative humidity, and preferably a relative humidity somewhat lower than 50%. This means that in rooms with important wallpapers the indoor climate is preferably not or only slightly heated and maybe slightly dehumidified.
