Pacemaker Lead Migration and Ventricular Perforation in a Patient Presenting with Chest Pain

Aventura Hospital & Medical Center, Department of Critical Care Medicine,
Aventura, Florida

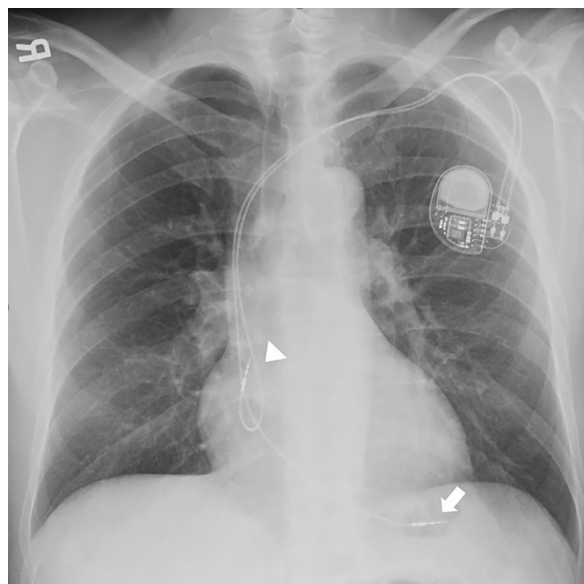
Image 1. Chest radiograph revealing ventricular pacer lead located distally overlying the right ventricle apical area (arrow) and atrial pacer lead within right atrium area (arrowhead).

A 52-year-old man with second-degree type II atrioventricular (AV) block and recent dual-chamber pacemaker placement presented to the emergency department with left sided chest pain for the prior two hours. Electrocardiogram showed a second-degree AV block with a ventricular rate of 45 beats per minute. Pacemaker interrogation revealed atrial sensing without ventricular capture. His chest pain was exacerbated with electrical stimulation despite lack of capture and resolved after disabling the pacemaker. Further imaging (chest radiograph [CXR] and point-of-care echocardiogram) revealed ventricular pacer lead mispositioned and a possible cause of acute chest pain (Images 1, 2). Coronal computed tomography (CT) of the chest confirmed lead migration beyond the right ventricle chamber. The patient was emergently taken to the operating room. Exploratory sternotomy confirmed ventricle perforation (Image 3). The patient underwent lead extraction, right ventriculorrhaphy, and epicardial right ventricle pacemaker lead placement. He was discharged home on hospital day four.

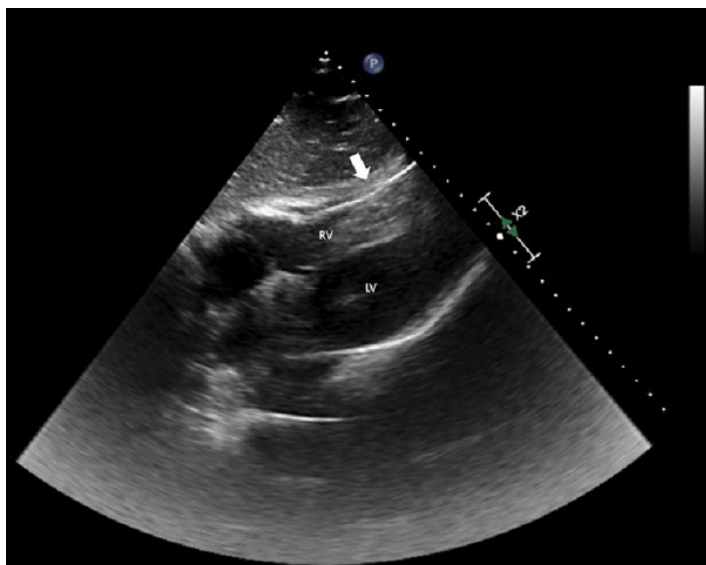
Image 2. Point-of-care echocardiogram subcostal view during systole showing ventricular pacer lead (arrow) beyond right ventricular chamber. No pericardial effusion is seen. RV, right ventricle; LV, left ventricle.

Chest pain, dyspnea, dizziness, syncope, and pacing or sensing pacemaker failure are commonly encountered clinical scenarios. Point-of-care echocardiogram allows for the clinician to promptly rule out emergent conditions such as hemorrhagic pericardial tamponade. Additional workup includes CXR and echocardiogram to evaluate for pericardial effusion; however, a non-contrast CT is usually required to confirm the diagnosis. Management is targeted based on patient's clinical stability and the extent of injuries to nearby structures.^{4,5} Clinically unstable or symptomatic patients often need emergent surgical repair.

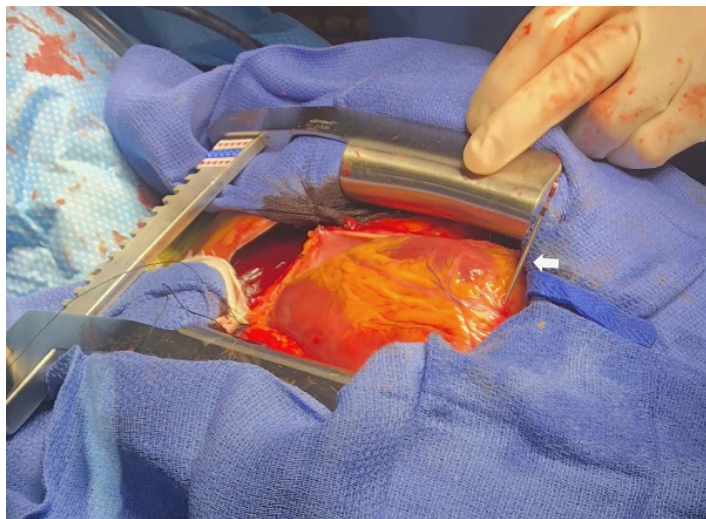
Image 3. Mediastinal exploration via sternotomy revealing ventricular lead piercing through the right ventricular apex (arrow).

perforation is attributed to continuous pressure of the thin lead per unit of the myocardial wall.^{2,3} Perforation of the right ventricular apex is the area most commonly prone to perforation due to weakness of the wall.
