## Would You Reduce this Knee?

### CASE PRESENTATION

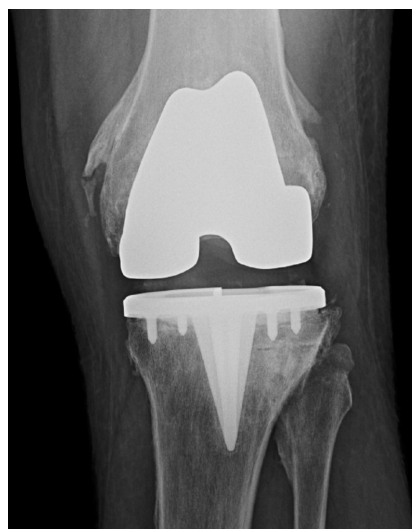
**Image 1.** Anteroposterior radiograph of the left knee showing no evident hardware failure in a patient with history of knee replacement who presented with pain and decreased range of motion.

A 46-year-old male with a history of knee replacement presented with pain and decreased range of motion of the left knee. He had felt a pop in his left knee when putting on his pants three days previously. He was standing on one leg with the weight-bearing left leg slightly flexed when the symptoms started. He had not been able to bear weight since. He was seen at a local hospital and initially diagnosed with a knee dislocation. Reduction was not carried out due to a stated allergy to ketamine, and transfer to a tertiary centre was recommended. The patient elected to go home and presented to our emergency department (ED) three days later. On physical exam, movements of the knee were severely limited. There was moderate effusion with no ecchymosis and the patient was unable to bear weight. Skin was intact. Distal pulses were palpable. Left knee radiograph showed no hardware failure in the anteroposterior view; however, the lateral view showed posterior subluxation of the tibia with polyethylene spacer unseated and displaced posteriorly (Images 1 and 2). Computed tomography provided more detail (Image 3).

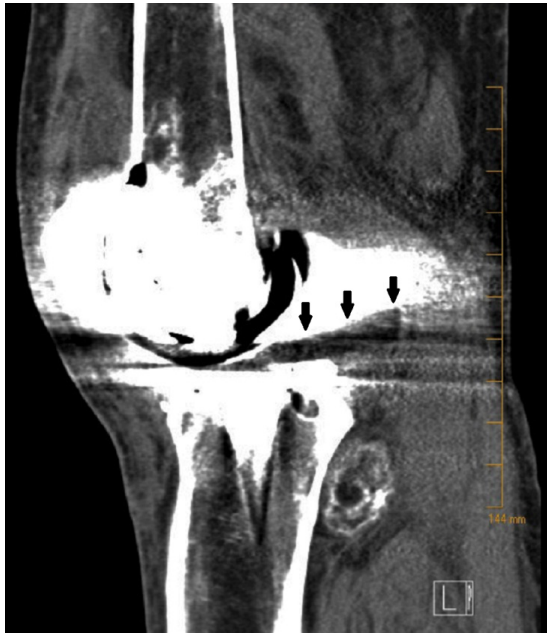
**Image 3.** Computed tomography of left knee (sagittal view) showing posterior subluxation of the tibia with posterior displacement of the tibial polyethylene spacer (arrows).

Dislocation of the polyethylene component of knee arthroplasty is a rare complication. The real incidence is unknown,<sup>1</sup> and only a few cases have been reported.<sup>1</sup> While dislocation of this component can be diagnosed on plain radiographs, it may be easily missed due to radiolucency of polyethylene. As with any knee dislocation, these injuries may be associated with injury to the popliteal vessels.<sup>2</sup> Reduction attempt in the ED should be avoided due to high failure rate of a closed reduction. Our patient was admitted to orthopedics for revision of the left total knee arthroplasty.
