NEW PERSPECTIVES ON GEOCONSERVATION
IN PROTECTED AND CONSERVED AREAS

**Threats go both ways
in the management of
volcanic protected areas***Daniel Tormey
Thomas Casadevall***ABSTRACT**

SPIRIT LAKE OUTFLOW SAFETY IMPROVEMENT PROJECT, MOUNT ST. HELENS NATIONAL VOLCANIC MONUMENT, USA

MANAGEMENT RESPONSE TO KĪLAUEA VOLCANO ERUPTION OF 2018 AND 2020, HAWAII' VOLCANOES NATIONAL PARK, USA

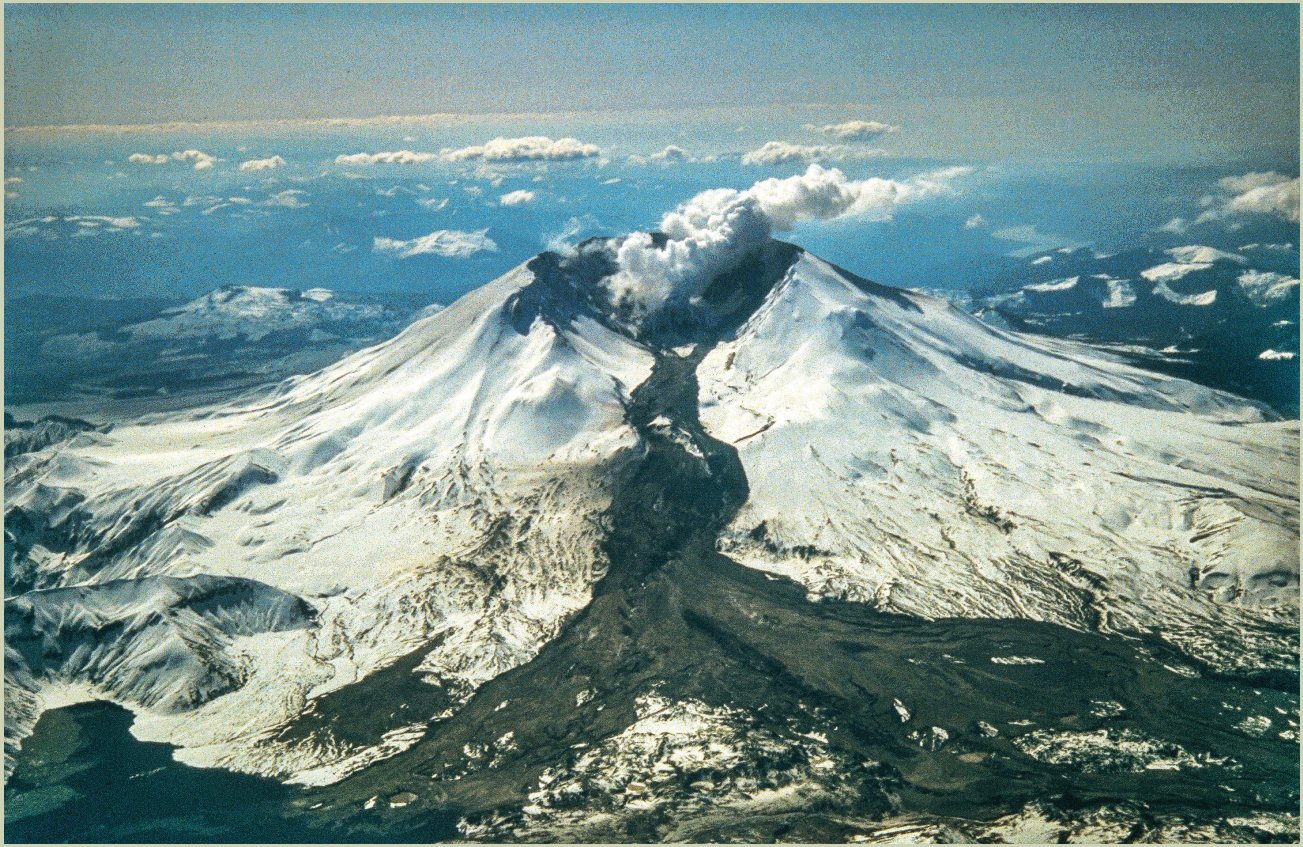
Mount St. Helens in 1982, showing the active volcano, a new lahar, and Spirit Lake (lower left). US GEOLOGICAL SURVEY / THOMAS CASADEVALL

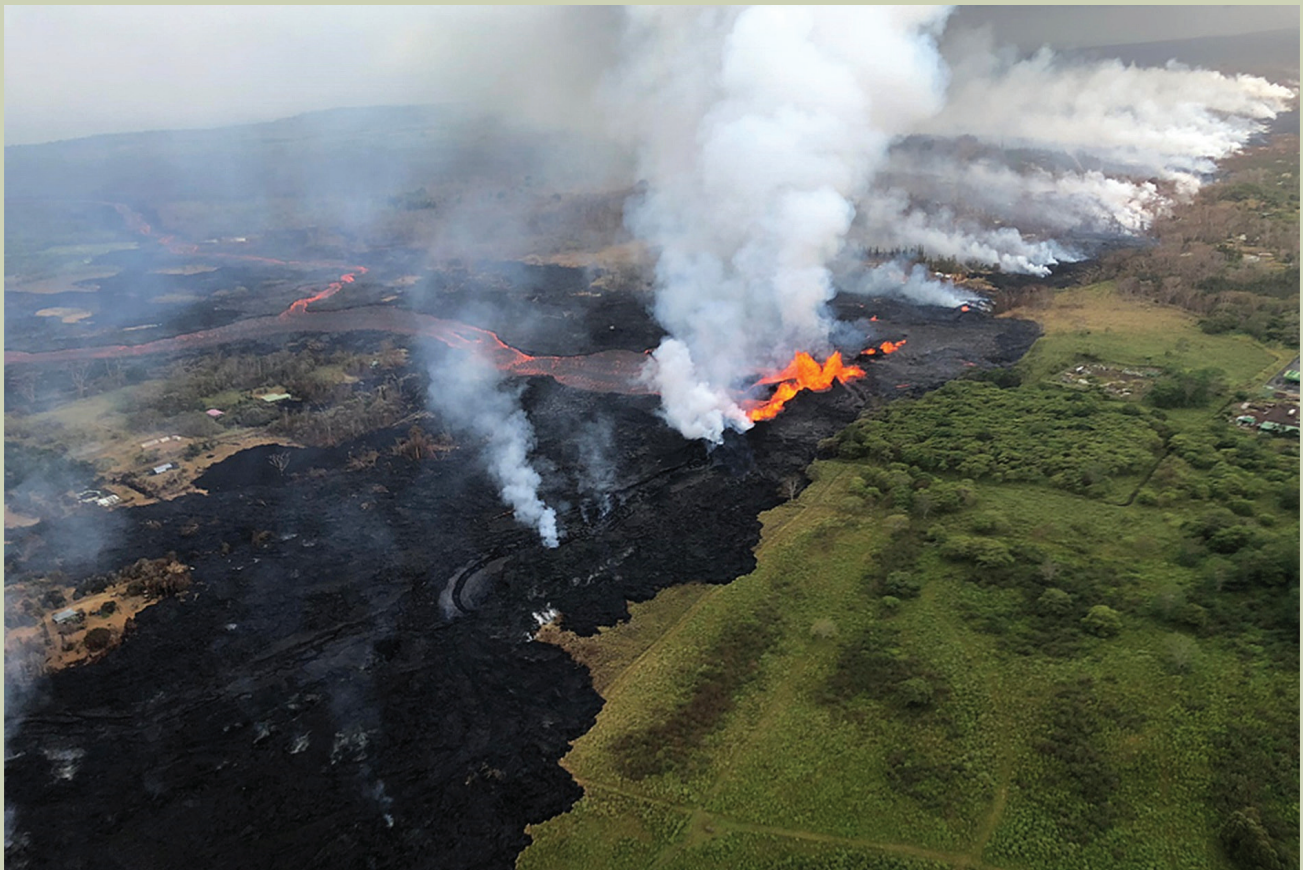
Aerial view of lava flow invading housing subdivisions in the Lower East Rift Zone, Kilauea volcano, Hawai'i, May 2018. US GEOLOGICAL SURVEY
