Child with Testicular Pain

Nicholas Otts, MD*
Ryan L. Webb, MD†
Josh Greenstein, MD*
Barry Hahn, MD*

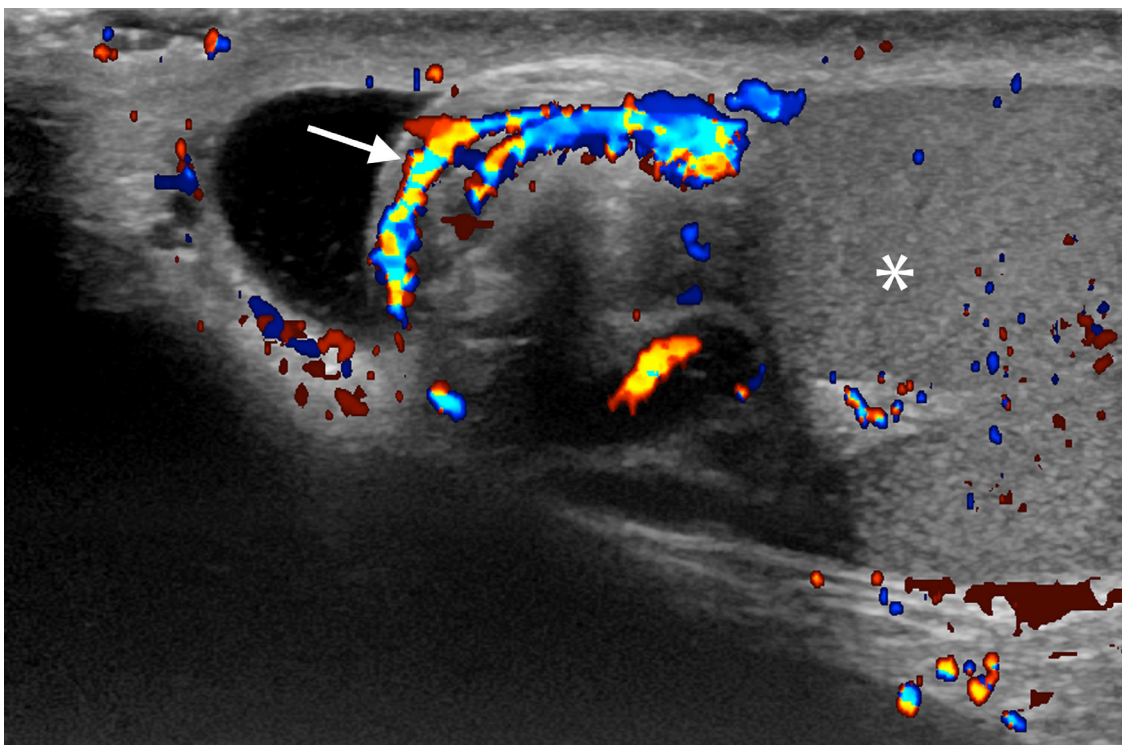
Image 1. Ultrasound of the spermatic cord demonstrates an edematous, heterogeneous extra testicular mass representing the twisted spermatic cord, with whorled color flow, the “whirlpool sign”(white arrow) around a central axis. Immediately adjacent is the testicle (white asterisk).

the whirlpool sign seen on point-of-care ultrasound (POCUS) of spermatic cord (Image).

early adolescence. Evaluation of testicular flow by color and spectral Doppler is the primary method of diagnosis.¹ However, evaluation with Doppler can be non-diagnostic due to the presence of low-velocity blood flow. Direct visualization of the spermatic cord by POCUS may elicit the whirlpool sign or an echogenic mass twisted around a central axis. As demonstrated by this case, whirlpool sign is diagnostic of torsion and can help identify torsion when Doppler is non-diagnostic.^{2,3} Thus, the whirlpool sign, although not frequently mentioned in emergency medicine literature, can be critical to the diagnosis of torsion in the ED and should be an ultrasound finding known to all emergency physicians.

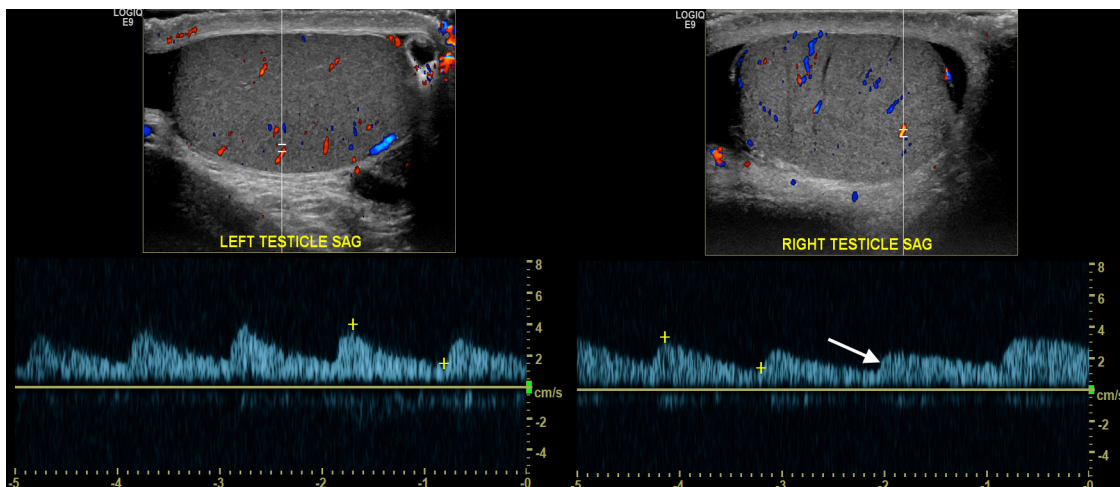
Image 2. Transverse ultrasound image of the left testicle obtained with a 15Mhz linear-array transducer using spectral Doppler demonstrates normal arterial wave form and flow (2A). Spectral Doppler of the right testicle (white arrow) demonstrates comparatively decreased systolic velocities with slowing of the upstroke (2B).

An 11-year-old boy presented to the emergency department (ED) with sudden onset severe atraumatic right testicular pain, associated with nausea and vomiting. On examination, the patient exhibited a slight horizontal lie of the right testicle as well as an absent cremasteric reflex on the right. Urology was emergently consulted. Though vascular flow was noted bilaterally on spectral Doppler (Images 2), the patient underwent surgical detorsion due to
