Ultrasound Detection of Patellar Fracture and Evaluation of the Knee Extensor Mechanism in the Emergency Department

Kiersten Carter, MD**
Arica Nesper, MD, MAS**
Laleh Gharahbaghian, MD*
Phillips Perera, MD*

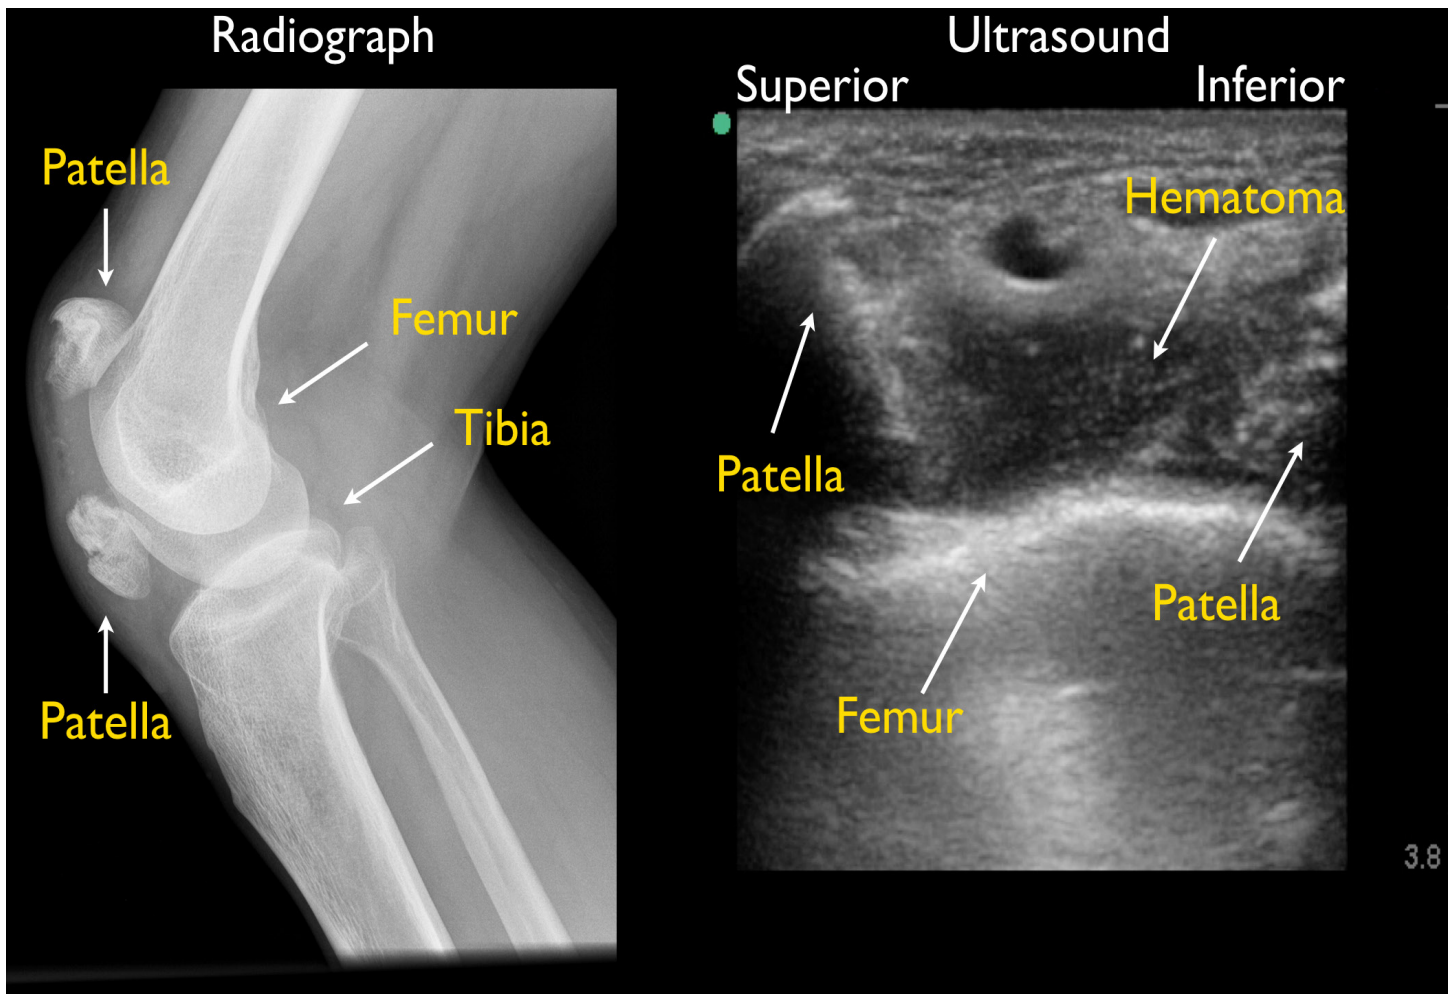
Figure. Patient's knee radiograph and ultrasound.

The high-frequency linear transducer is used for this MSK US application. A fracture is identified when there is a disruption in the normal continuous bright (hyperechoic) interface between the bone and soft tissue. Identification of a hypoechoic (dark) collection, suggestive of a hematoma, can also guide the clinician to the site of cortical disruption.¹⁰ In acute knee trauma, MSK US has been shown to have increased sensitivity, 94% versus 84%, over plain radiography in the diagnosis of fractures.⁵

To further assess the knee extensor mechanism using US, the probe is positioned in the long-axis configuration, cephalad to the superior pole of the patella and directly over the quadriceps tendon. It is then moved sequentially caudal over the patella down to the patellar ligament, allowing detailed assessment of these structures (see video).¹¹
